August 2002 flood  
in the watercourses of the  
Osterzgebirge mountains  
Event Analysis

# Management-Report

Sächsisches Landesamt für Umwelt und Geologie

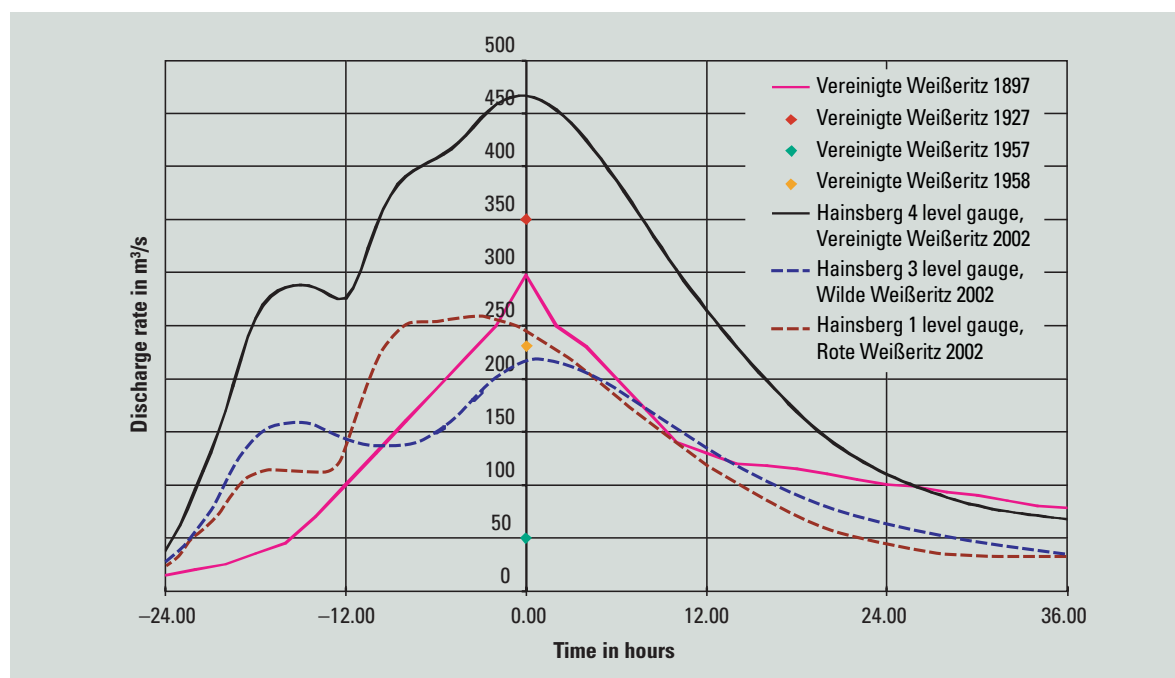
Fig. 3: Historical hydrograph curve and peak discharge rates for the river Weißeritz compared with the flood on 13 August 2002

Because of its geological condition and the moisture it already contained, the soil was incapable of absorbing much water and was quickly saturated. As a result, it could neither hold water, nor delay discharge in any significant way. Consequently, 60 to 90 per cent of the precipitation ran off in many areas in a very short space of time. This led to discharge rates far beyond any known values in almost all of the investigated watercourses (see Fig. 3).

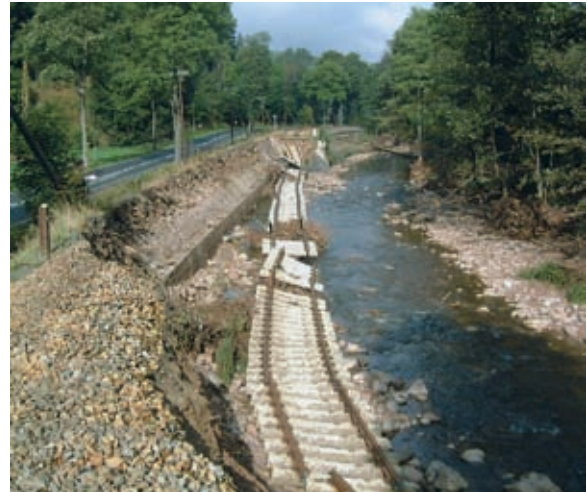
Fig. 4: Complete erosion of the railroad embankment in the valley of the river Müglitz. The exposed old retaining wall, which used to give the stream a much wider bed, is noteworthy (photo: LTV [State Dam Management Office], 2002).

Several hundred thousand cubic metres of sediment were moved in the most heavily affected streams, the Weißeritz and the Müglitz. The main sources of material included collapsing revetment walls and their backfill, road and railroad embankments, as well as artificial and semi-natural reinforcements made of unconsolidated material. The material was mostly transported over short distances and deposited either in shallow sections with little transport capacity or in front of obstructions such as bridges. Transport processes considerably modified the river beds, even entire channels were displaced. The flow capacities of river cross-sections and at bridges were exceeded almost across the entire region. As a result, large areas, and in particular villages and towns, were flooded.

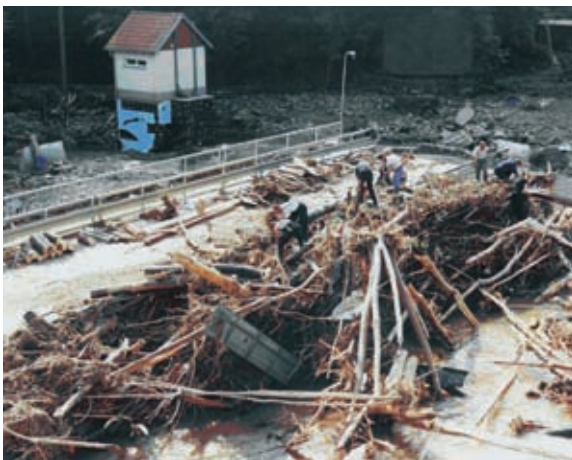
Fig. 5: Choked and damaged bridge in the valley of the river Müglitz—temporary bridge in Schlottwitz, upstream from the confluent Trebnitzbach stream (photo: LTV, 2002).

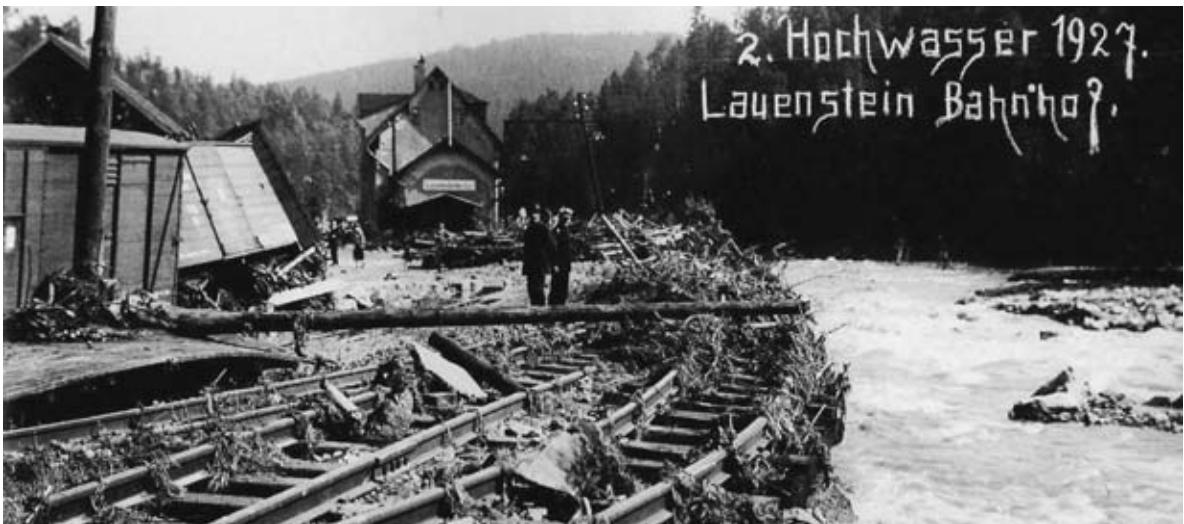
Fig. 6: Lauenstein railway station after the flooding of the river Müglitz in 1927 (photo: taken from POHL, 2003)

Similar damage as a result of sediment and drift wood etc. are documented for all major historic floods in the Osterzgebirge mountains. However, solid material processes only become relevant when the flow rate exceeds a certain limit, which leads to massive overbank flow. In such cases, damage increases drastically.

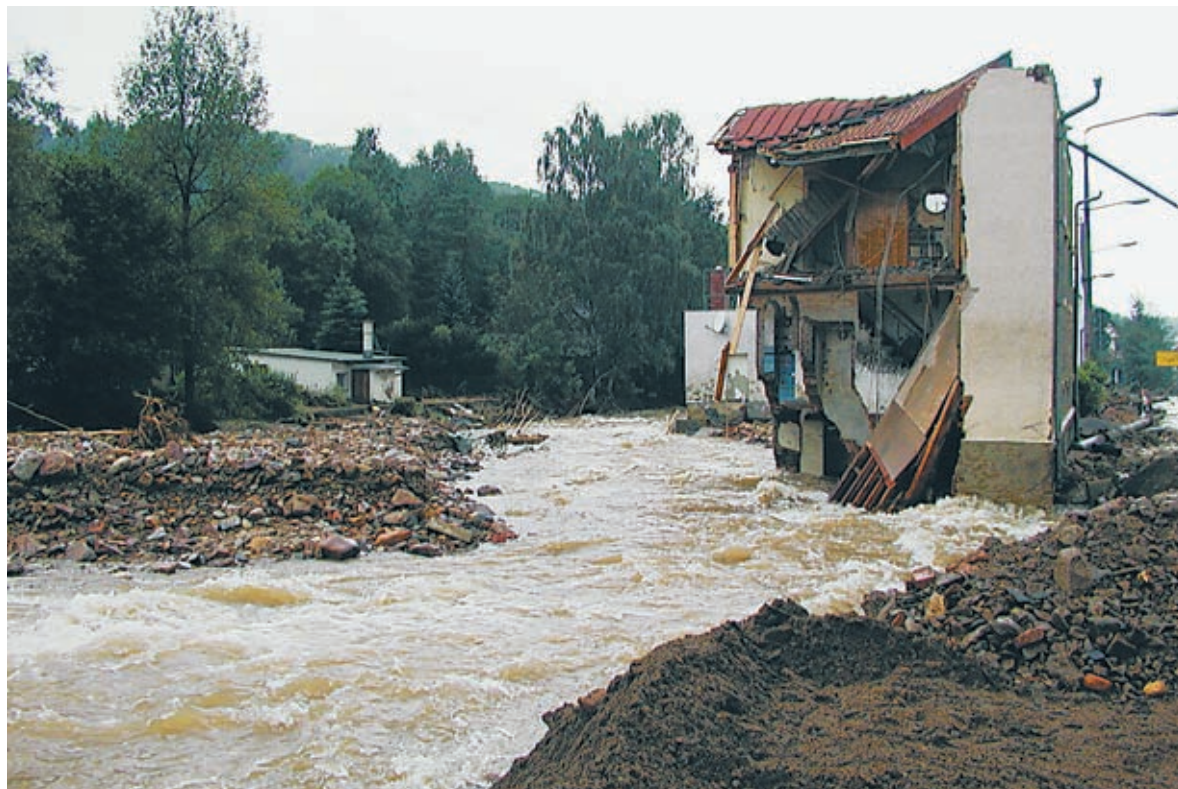
Fig. 8: Destroyed building and channel displacement of the Rote Weißeritz in Schmiedeberg (photo: GOTTFRIED HEROLD, 2002)

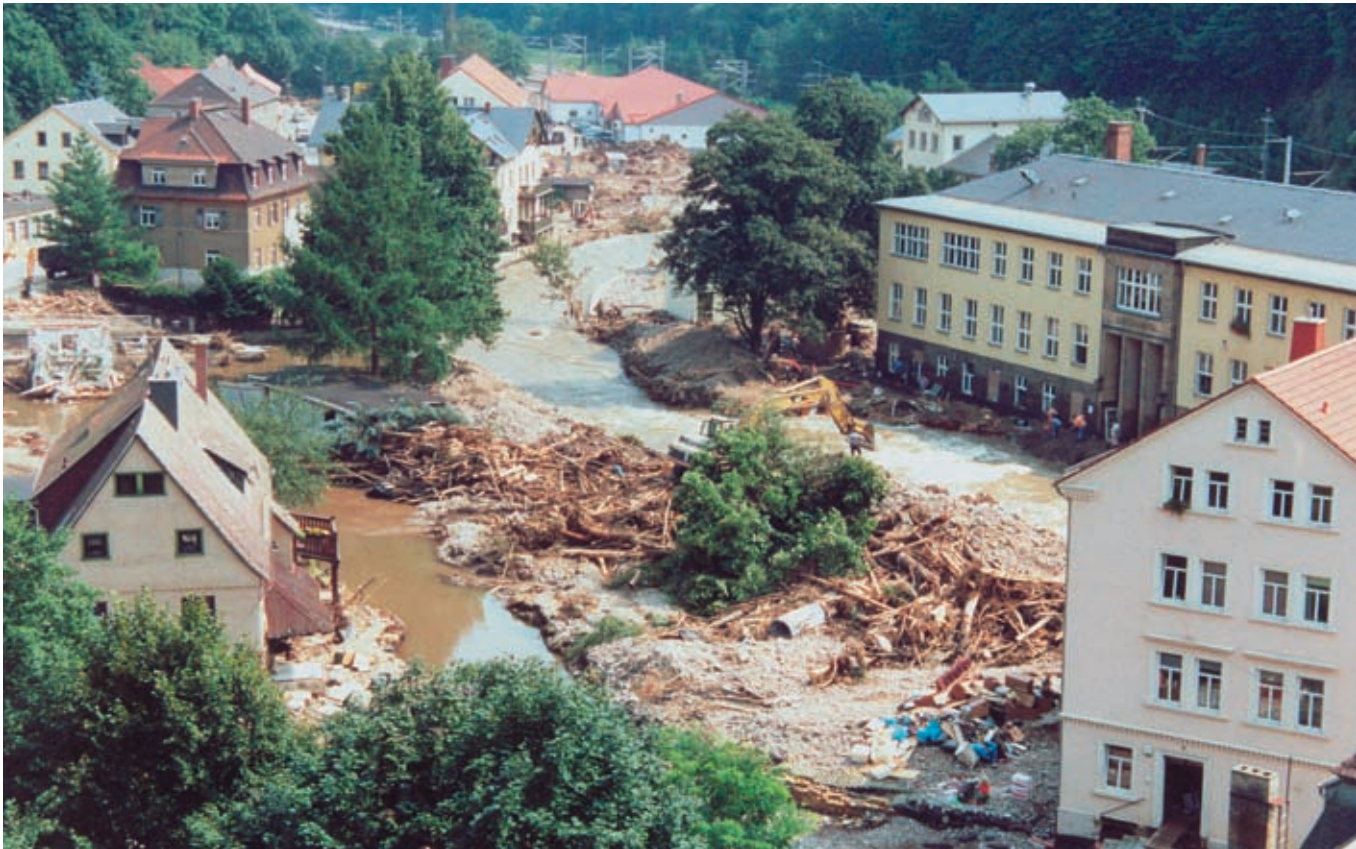
Fig. 9:  
Removal of debris  
in Tharandt on  
18 August 2002  
(photo: RAINER  
ELZE, 2002)

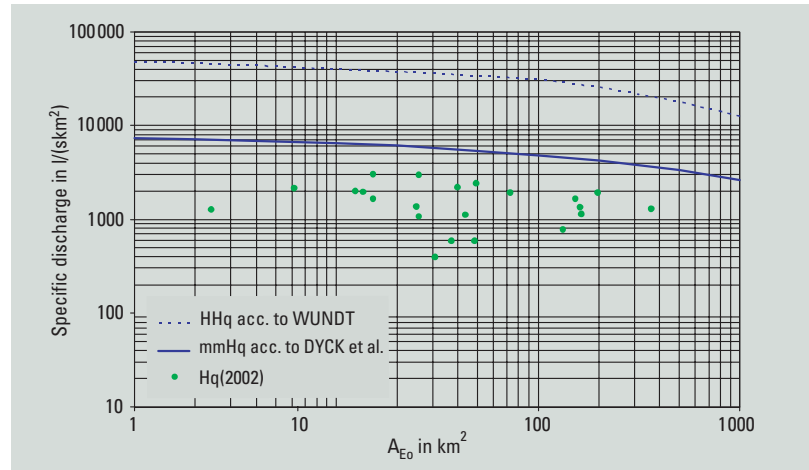
Fig. 11: Comparison of the specific discharge during the August flood Hq (2002) and the envelope curves of maximum known discharge volumes world-wide (according to WUNDT) and in southern Saxony and Thuringia (according to DYCK)

The analysis showed that the flood of the left bank tributaries of the Upper Elbe in 2002 cannot be classified as a 1:10,000 year event or even a maximum possible flood (see Fig. 11).

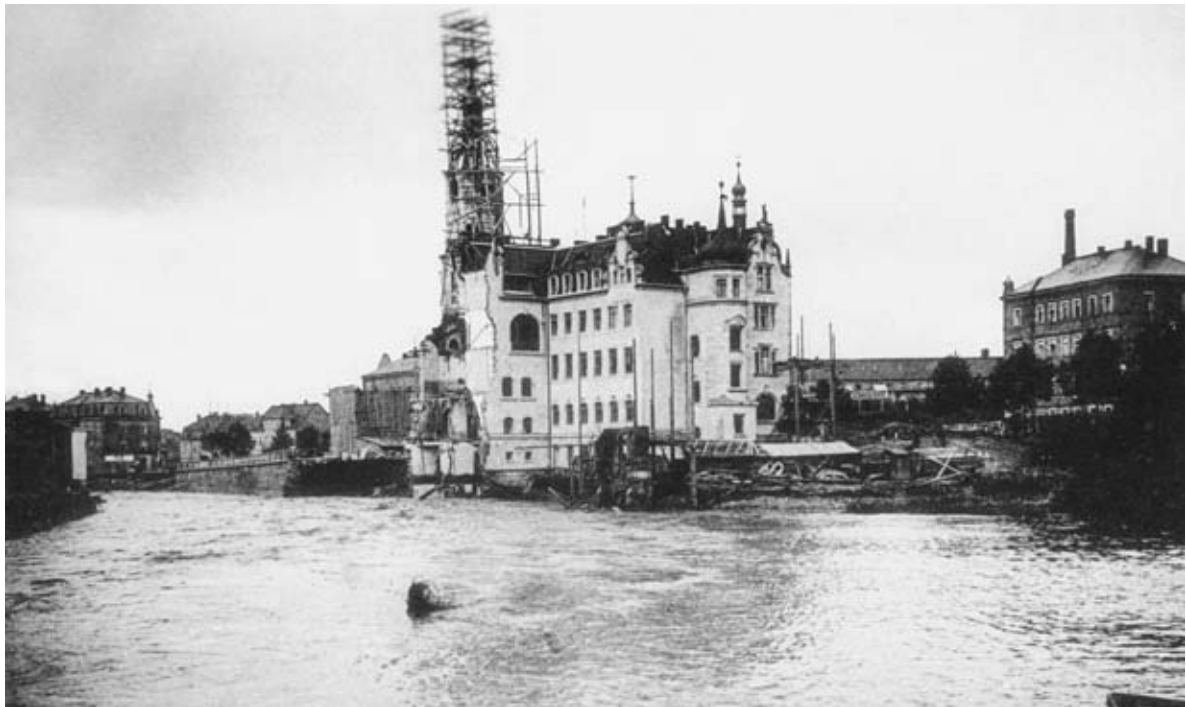
Fig. 13:  
Damaged wing of the Löbtau town hall after the flooding of the river Weißeritz in 1897 (photo: LfUG [State Office for Environment and Geology])

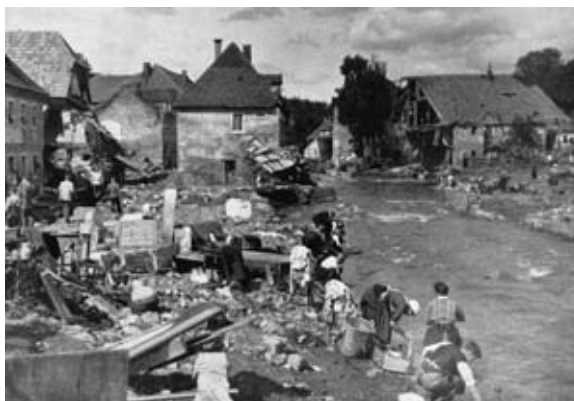
Fig. 14:  
Town of Berggießhübel in the valley of the river Gottleuba: on the first Sunday after the 1927 flood (photo: taken from MARSCHNER, 1927)

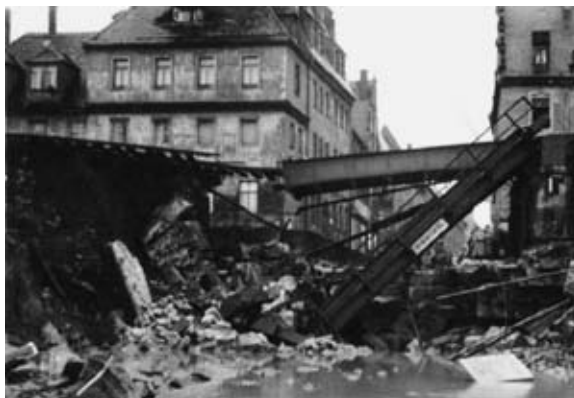
Fig. 15:  
Town of Pirna after the river Gottleuba flooded in 1957 (photo: LTV)

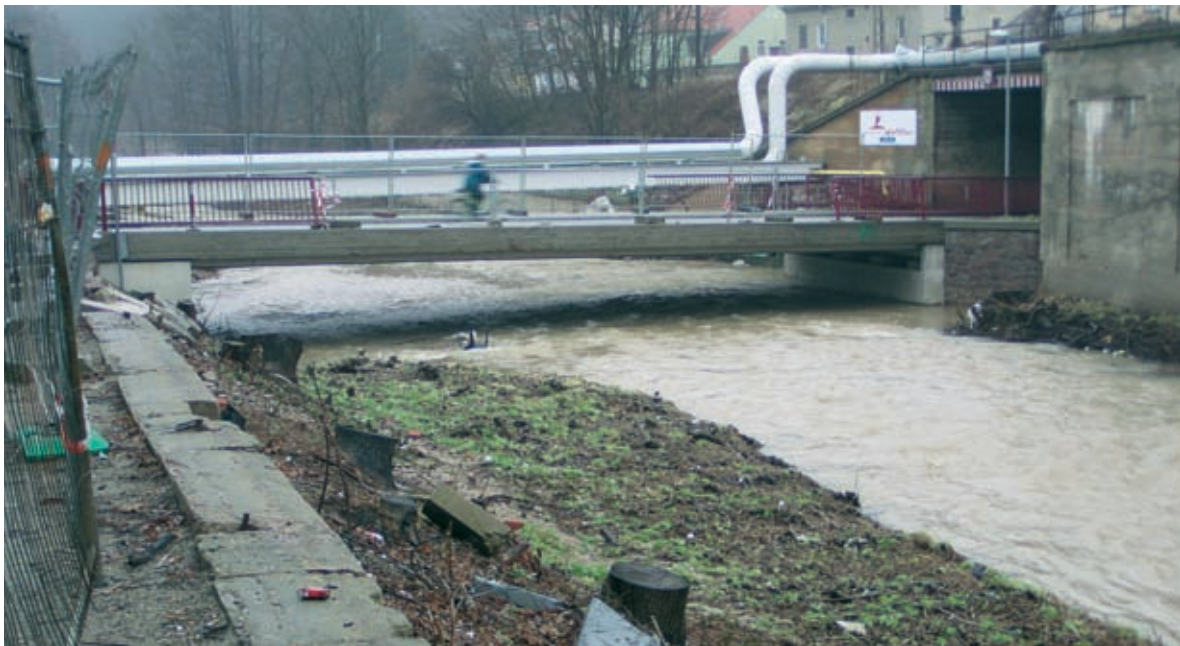
Fig. 16: Road bridge over the Triebisch stream in Meissen, max. flow rate with no freeboard approx. HQ(50) (photo: LUKAS HUNZINGER, 2003)

incapable of coping with the volume of water, have been identified in almost all affected settlements. For example, some one-third of all bridges in the settlement areas are too small to cope with a hundred-year flood (HQ[100]). Quite apart from the consideration of the above-mentioned bottlenecks, the current development of the river beds in several places is not enough to discharge anything more than a HQ(20).

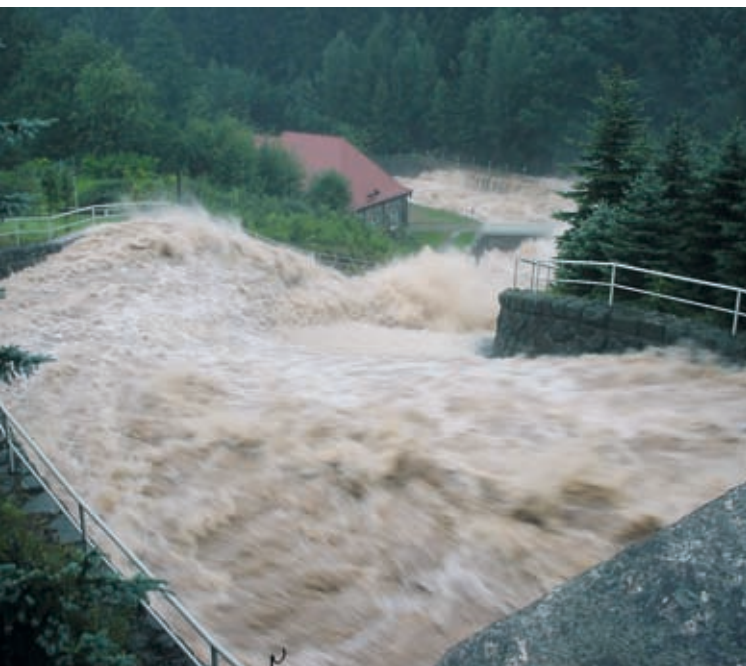
Fig. 17: Spillway of the Malter dam on 13 August 2002 (photo: LTV, 2002)

The catchments of the Gottleuba, the Lockwitzbach and the Weißeritz have one or several flood retention reservoirs and dams with flood control function. Even though their limit capacity was exceeded, and water ran over the spillways, these facilities considerably delayed the discharge. For this reason and because the areas below the dams and reservoirs were also hit by heavy rain, the flood control facilities were unable to prevent widespread major damage.

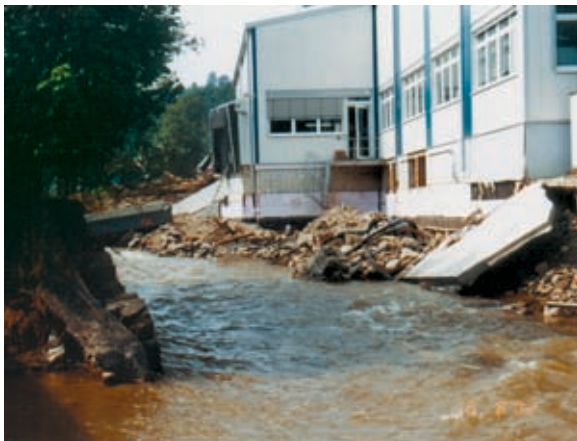
Fig. 19: Destroyed revetment of the Müglitz stream in Glashütte, 2002 (photo: LTV, 2002)

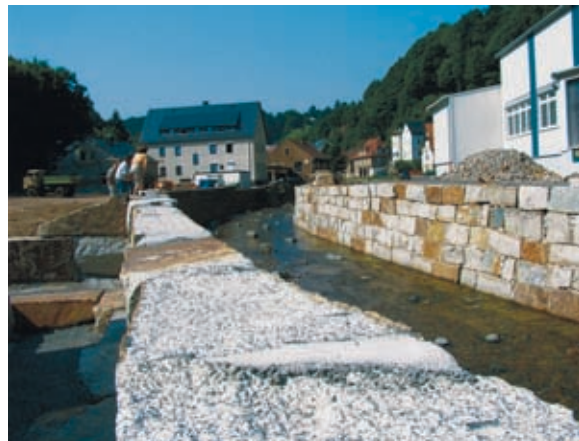
Fig. 20: Same revetment of the Müglitz stream in Glashütte, 2004 (photo: LTV, 2004)
